Section 4 Results of Fieldwork

4.1 Construction Sheet RW001

Archaeological Inventory Survey, HHCTC Construction Phase I, Honouliuli, Hō'ae'ae, Waikēle, Waipio, and Waiawa Ahupua'a, 'Ewa District, Island of O'ahu

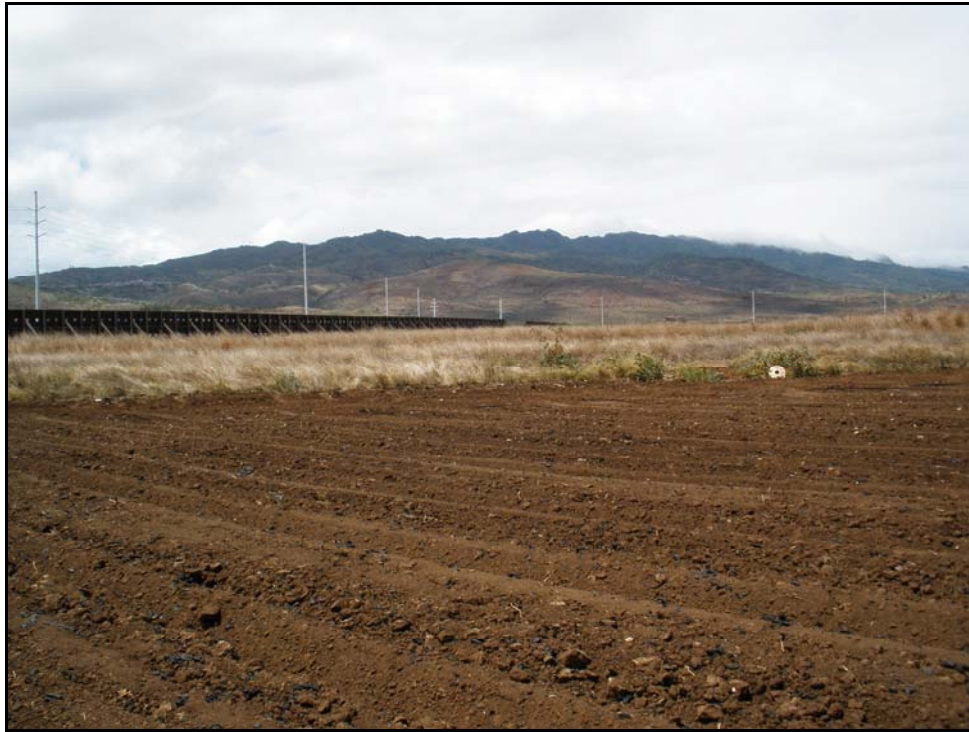
Figure 61. Photo of current conditions at location for the UH West Oahu Park and Ride Facility along the west side of Aloun Farms showing active agricultural fields and access (dirt) roads

The UH West O'ahu Station is located within the construction zone for North-South Road, while its two park and ride facilities are situated in agricultural fields currently cultivated by Aloun Farms (Figure 61). Both activities would have generated significant land disturbance to have removed any surface cultural resources that may have been present. No cultural resources were observed within this portion of the project area.

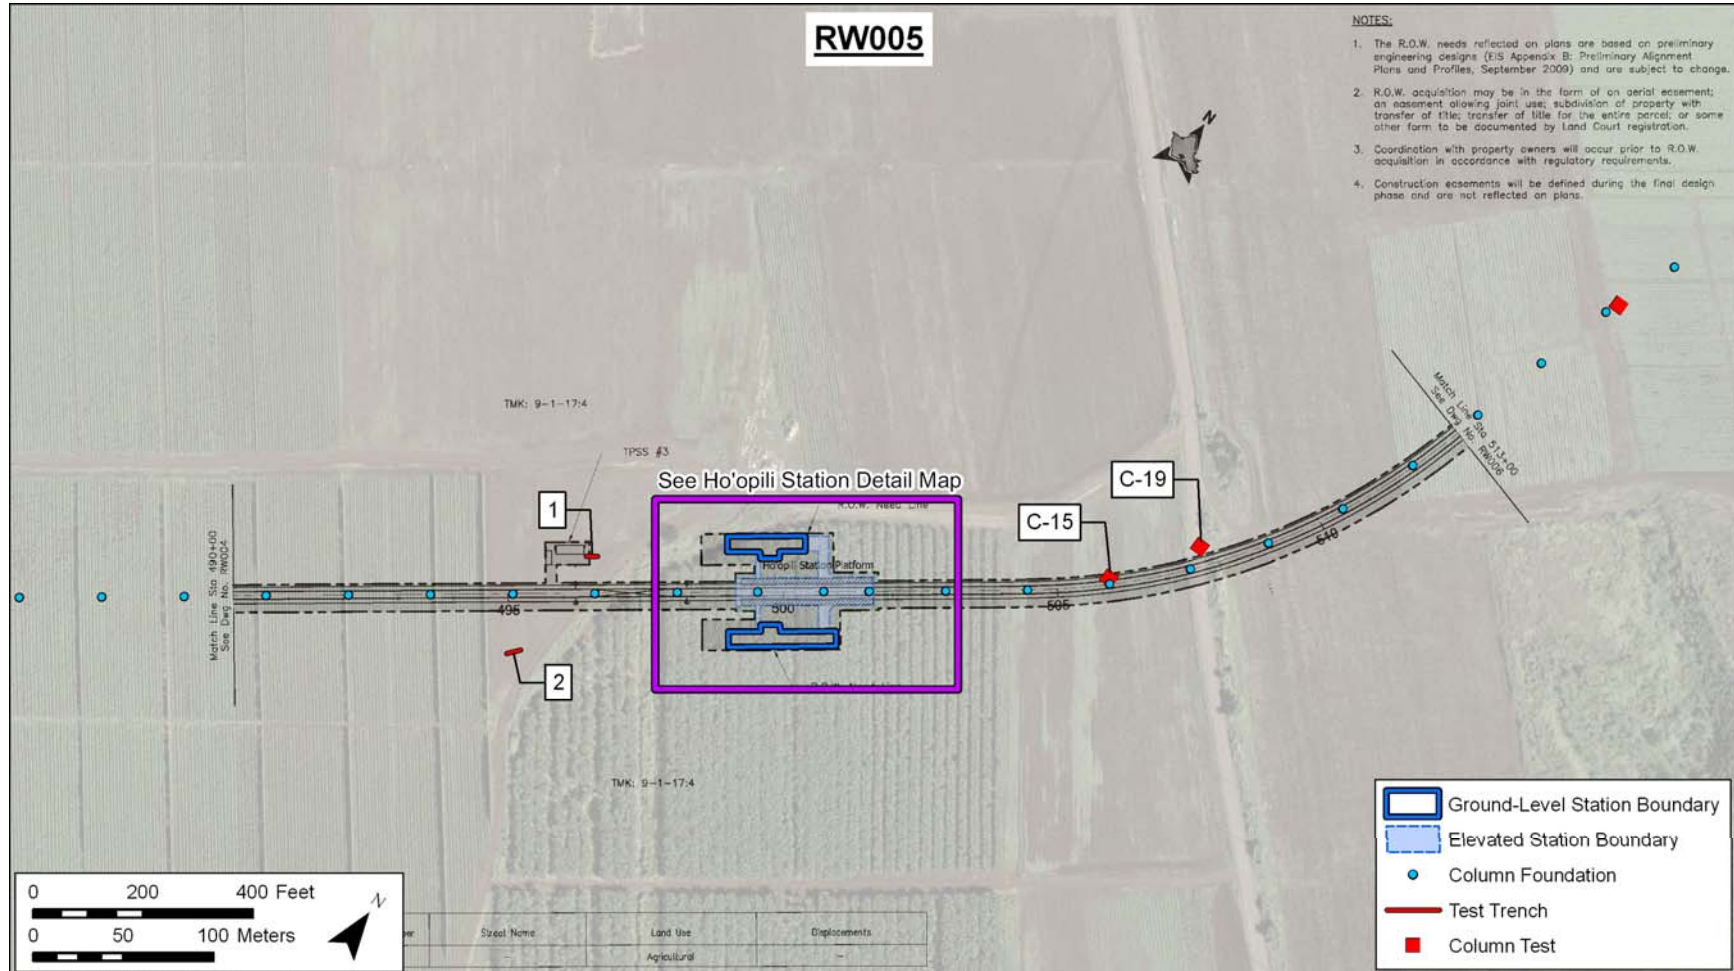
Figure 82. Photo of location for Ho'opili Station within the Aloun Farms agricultural fields area

This segment of the project area lies entirely within the actively cultivated fields and dirt access roads of Aloun Farms (Figure 82). Modern and historic agricultural activities in this area would have removed any surface cultural resources that may have been present. No cultural resources were observed within this section of the project area.
